## **SANYO Commercial Solutions**

# **Technical Service Bulletin**

2007.06.11

Procedure for correcting Error Code E01, typically caused by "Reversed Polarity"

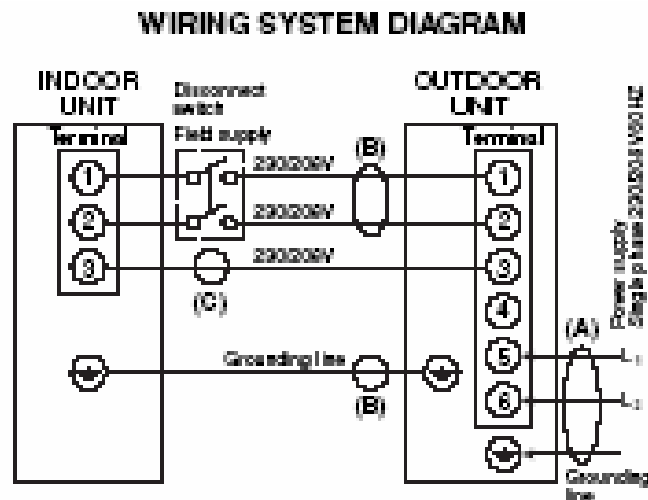
Figure 1

- Verify the wiring which runs from the indoor to the outdoor unit, which should be a 14-3 conductor (or larger per local code requirements) plus ground wire.
- These three wires supply the 208/230 VAC from the outdoor unit to also power up the indoor unit.
- These wires must be landed terminal 1 to 1, 2 to 2 and 3 to 3 from the outdoor to the indoor unit's wire termination strip (see Figure 1).
- **When the wires on terminals 1 & 2 are crossed from the indoor to the outdoor unit, an immediate error will occur upon powering up the system.**

- Turn power off to the system.
- Reverse the wires landed on terminals 1 & 2 at either the indoor or outdoor unit's wire termination strip.
- Once the system is powered back on the system should now operate normally.
- There is a standard 3 minute delay before the condensing unit will come on and run.
